Problem-solving endodontics

John Rhodes presents an interactive, practical and problem-solving solution in endodontics. This month, he looks at the non-surgical retreatment of a maxillary central incisor restored with a post crown

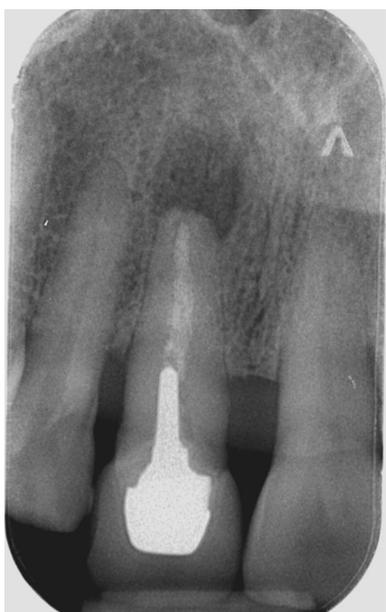
Figure 1: A failed post crown UR1

A paralleling radiograph (Figure 1) shows that the existing, poorly condensed root filling has failed and there is chronic periapical periodontitis present. The crown is reasonable and there does not appear to be significant loss of marginal integrity or obvious coronal microleakage.

The post is slightly short and the tip lies above osseous level, possibly as a result of marginal bone loss. The tooth is not mobile and there is sufficient supra-gingival tooth substance to provide a ferrule.

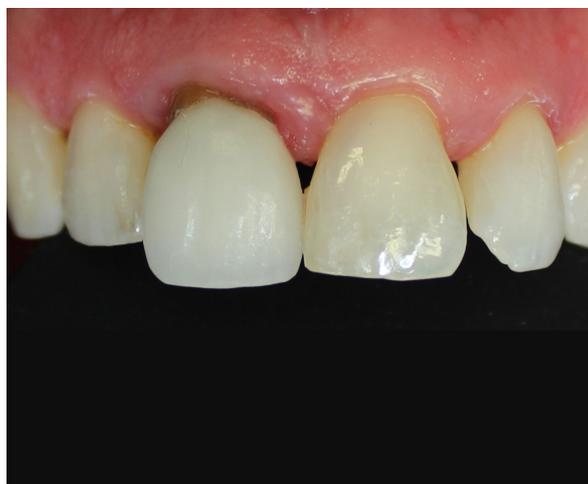
Figure 2: The crown on UR1 is reasonable; there has been some recession and there is sufficient tooth substance to provide a ferrule

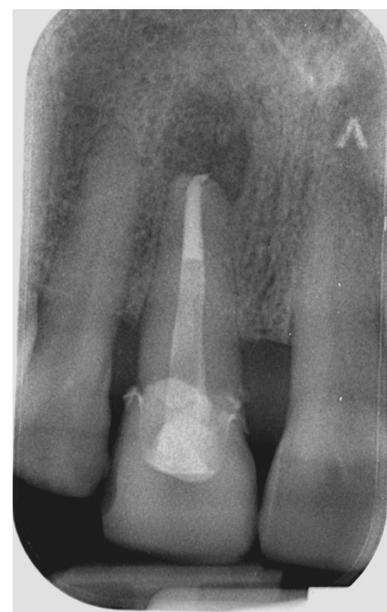
Figure 3: The completed root canal treatment

In order to prevent obturating material being extruded from the root canal, a stop had to be created. Small plugs of collagen matrix (Haemocollagene, Septodont) were placed in the dried canal, the first packed through the apex and the second packed so that it was level with the end of the root. The apical part of the root canal could now be obturated with thermoplasticised gutta percha without

As mentioned previously, temporary post crowns provide a notoriously poor seal, and so the best time to place the definitive post and core is immediately after obturation. This ensures that the disinfected post-hole does not become contaminated and provides optimal apical to coronal seal. In order to remain conservative, the post-hole did not need to be enlarged any further but the post length was extended apically below osseous level.

A fibre post was cemented and core fabricated with dual cure composite material (Core-X, Dentsply). A temporary acrylic crown was then cemented before returning the patient to the referring dentist for definitive restoration. ■
